The Corporation of the Town of LaSalle

Date	July 4, 2018	Report No:	PW-28-18
Directed To:	Mayor and Members of Council	Attachments:	~Figures 1-6
Department:	Public Works	Policy References:	
Prepared By:	Mark Beggs – Manager of Parks and Roads		
Subject:	Vollmer Sports Field Drainage

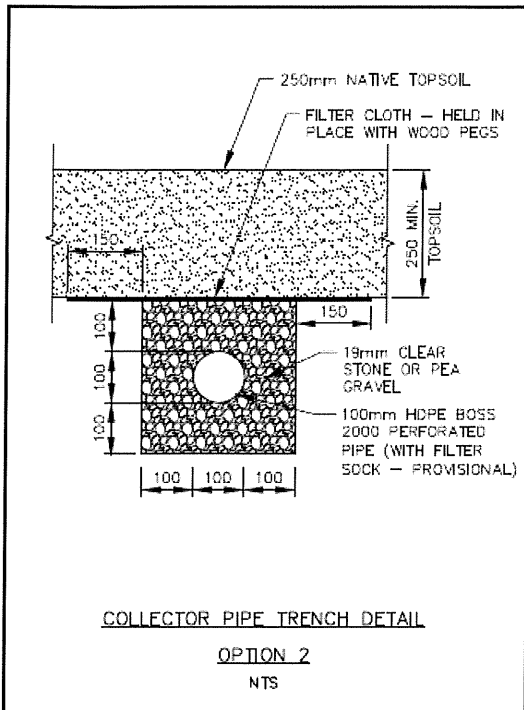
2. The header pipes leading to the outlets are intact and there is water running through the system and outletting correctly.
3. The catchbasins are intact and generally as shown on plans. In some cases, there are additional catchbasins in the complex.
4. The collector pipe system was spot excavated in one location between fields and it was confirmed there is:
 - a. A 100mm perforated pipe with filter sock, intact.
 - b. There appeared to be adequate clear stone, and filter cloth present at location of excavation as per As- Built drawings. At the location exposed, it appears that the clear stone and filter cloth have not been compromised.

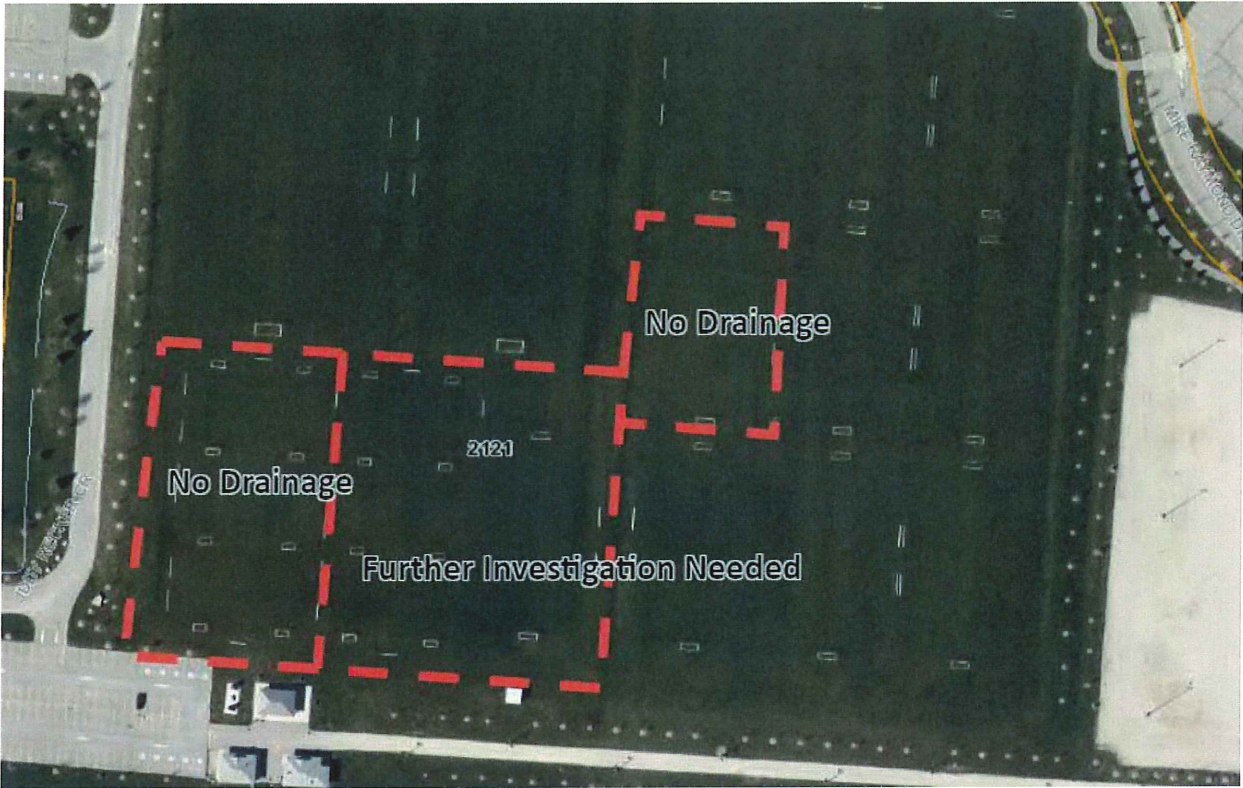
Fig. 1 Soccer - Areas currently without drainage

1. The 100mm perforated collector drainage was installed in the area of the “G” fields. (Fig. 1)
2. The 100mm perforated collector drainage was also not installed in the area of “W4”. The original plan was for a structure to be built in that location. It was later converted to a field. (Fig. 1)
3. There is not any drainage in any of the baseball outfields (Fig. 2)

1. Complete investigations in the baseball fields where possible in fall after season is complete with possible test digs on fields(s)
2. Complete investigations in soccer fields in fall where possible after season is complete with excavation of a test area on the field(s)

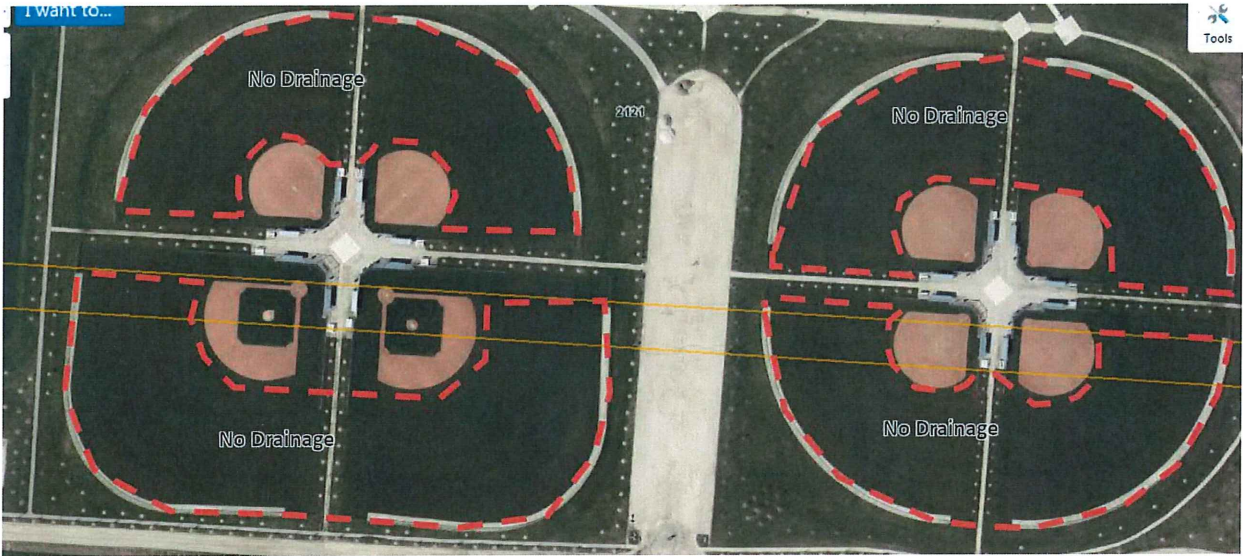
Fig. 2 Baseball – Areas currently without drainage

9. At this time, we have not completed the baseball investigation. We know there is some drainage in the infields, and the drainage was not installed in the outfield originally due to budget constraints.
